ASTM C672 - Scaling Resistance of Concrete Surfaces Exposed to Deicing Chemicals

Project No.	3819	Cement Content:	5.3
Project Name:	Lab Services	Water-cement Ratio:	0.5
Cast Date:	9/7/2024	Slump:	4"
Set ID:	RC-1 (Greymont Dust)	Air:	6.0%
Lab Number:	37572		
Solution/Concentrate:	Calcium Chloride 40g/L		
Admixtures:	AT-30 (65 mL), Quad 842 (63 mL), Recover (21 mL), EXP 950 (85 mL)

Project No.	3819	Cement Content:	6.5 Bags
Project Name:	Lab Services	Water-cement Ratio:	0.47
Cast Date:	9/7/2024	Slump:	4"
Set ID:	RC-2	Air:	5.50%
Lab Number:	37572		
Solution/Concentrate:	Calcium Chloride 40g/L		
Admixtures:	AT-30 (60 mL), Quad 842 (107 mL), Recover (28 mL)

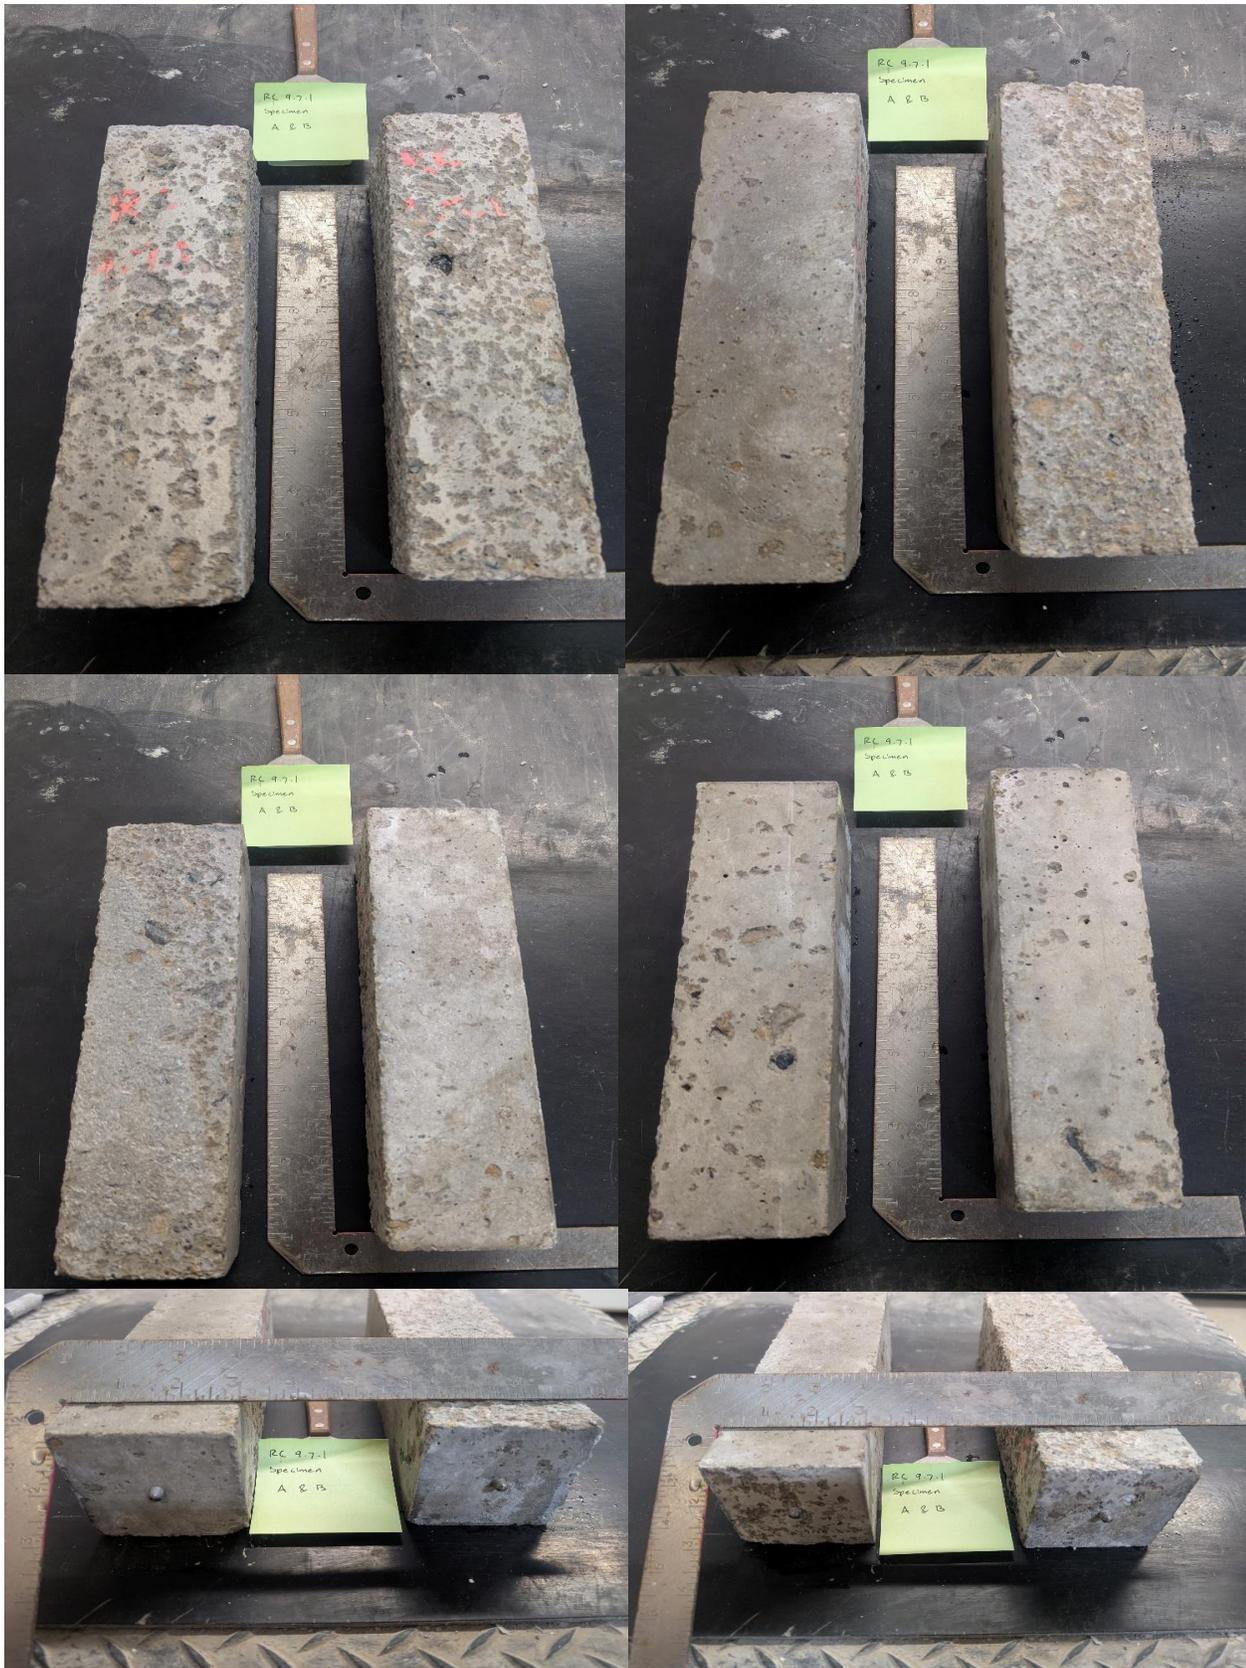
5 Cycles: Rating 1	•Specimens showed very slight scaling. All faces have little to no scaling. No coarse aggregate visible.
10 Cycles: Rating 1	•Specimens showed very slight scaling. All faces showed minimal scaling. No coarse aggregate visible.
15 Cycles: Rating 2	•Specimens showed slight to moderate scaling. Two of the four main faces showed moderate scaling. The other faces showed slight scaling. No Coarse aggregate visible.
25 Cycles: Rating 3	•Specimens showed moderate scaling. Two of the four main faces showed moderate scaling, with some coarse aggregate visible. The other two main faces showed slight scaling, with little to no coarse aggregate showing.
50 Cycles: Rating 4	•Specimens showed moderate to sever scaling. Two of the four main faces had coarse aggregate visible throughout the entire face. The other two main faces only had moderate scaling, where only some coarse aggregate is visible.

Pictures of all faces and ends after 50 Cycles.

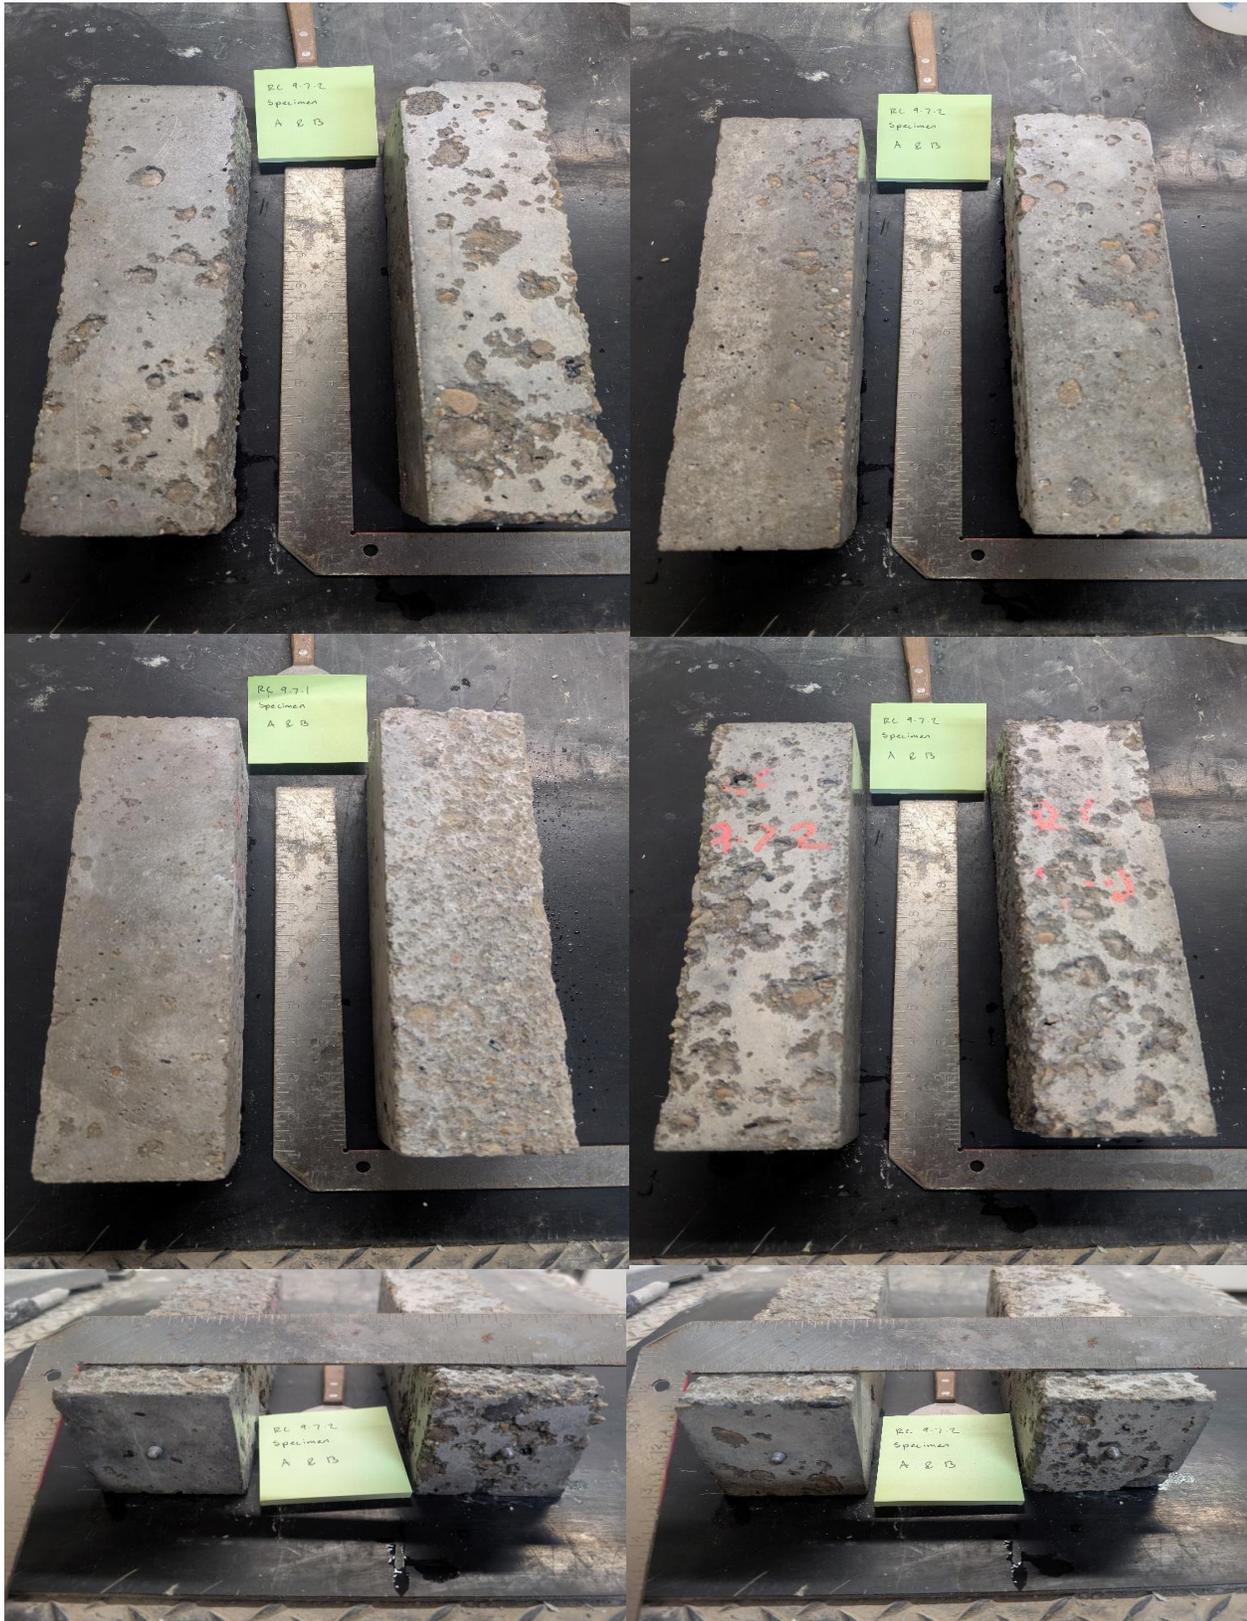
5 Cycles: Rating 2	•Specimens showed slight to moderate scaling. Two of the four main faces showed moderate scaling. The other two faces showed slight scaling. No coarse aggregate visible.
10 Cycles: Rating 3	•Specimens showed moderate scaling. Two of the four main faces showed moderate scaling, with some coarse aggregate visible. The other two faces showed slight scaling
15 Cycles: Rating 3	•Specimens showed moderate scaling. Two of the four main faces showed moderate scaling, with coarse aggregate visible almost across the entire face. The other two faces showed slight to moderate scaling, with minimal coarse aggregate visible.
25 Cycles: Rating 4	•Specimens showed moderate to severe scaling. Two of the main faces had coarse aggregate visible throughout the entire faces. The other two faces showed moderate scaling, where only some coarse aggregate is visible.
50 Cycles: Rating 5	•Specimens showed severe scaling. Coarse aggregate was visible on all faces. Two of the main faces have more scaling across the entire face while the other two still have coarse aggregate visible across the entire surface but not as much scaling.

Pictures of all faces and ends after 50 Cycles.
